LENDLEASE COMMUNITIES

SPRING MOUNTAIN

SITE BASED MANAGEMENT PLAN - HAUL ROAD

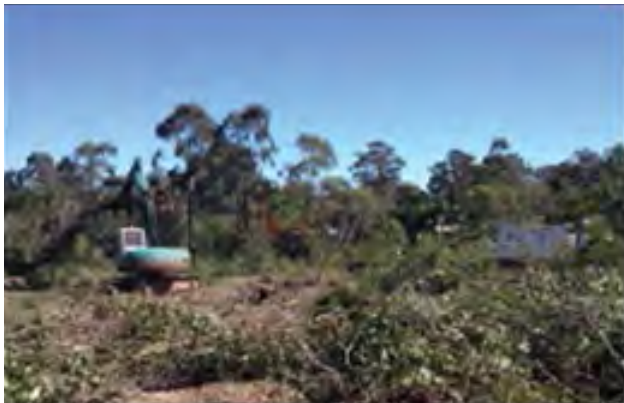
Photo: Control clearing of vegetation

Clearing activities should be undertaken in accordance with the with all management plan requirements and associated approval conditions. It is acknowledged this clearing line is offset 10m from the ultimate clearing line. Additional lineal clearing will be completed as part of phase 2 works.

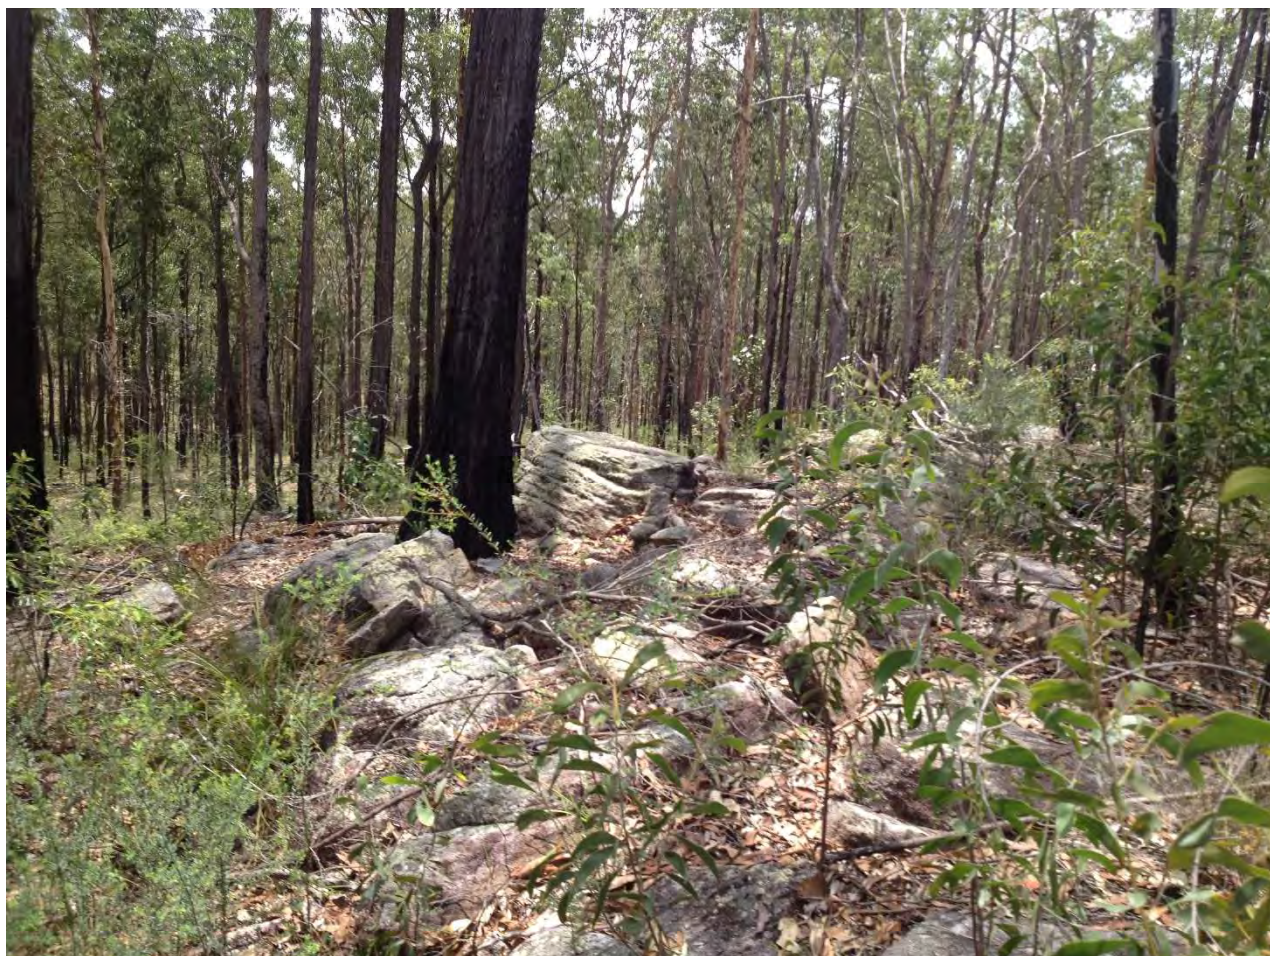
Photo: Exposed rocky terrain observed along the ridge line.

Only a small area of exposed rock surface was observed along a portion of the ridge line adjacent to the cleared track throughout the transect area. This area was thoroughly searched specifically for both *Marsdenia coronata* (Slender Milk Vine) and *Plectranthus habrophyllus* (Plectranthus) both of which have habitat niches suited to this terrain. The remaining area retained an open understorey and ground layer.
